Case Study 4: **TERRA COTTA REPLACEMENT WITH GLASS FIBER REINFORCED CONCRETE**

Project: **RANDELL HALL, DREXEL UNIVERSITY**

Location: **PHILADELPHIA, PA**

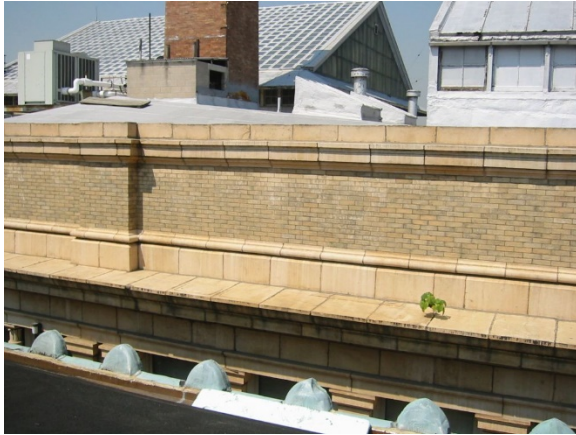
The inspections began with visual observations from grade and adjacent roofs using binoculars and telephoto cameras. In many areas the cornices appeared to be in relatively good condition. However, the horizontally projecting cornices skyward facing surfaces did not have cap flashings and there were indications of water infiltration and retainage within the original terra cotta cornices including vegetation growth and shell cracking at vertical ribs. (See Figure 2 and Figure 3.) Previous repair efforts were also observed. These were primarily cracks sealed with sealant. No reinforcing or pinning was observed. (See Figure 4.)

Figure 2. Vegetation growth from mortar joint

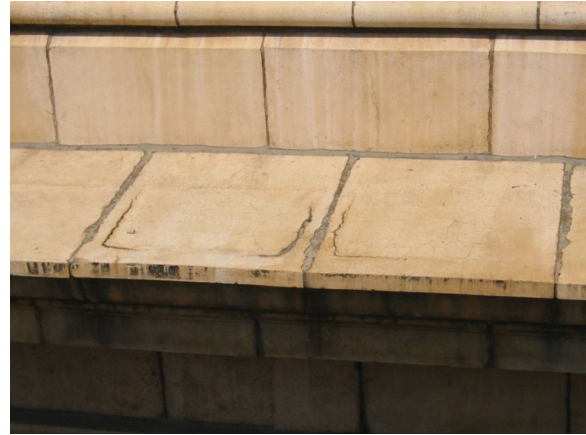
Figure 3. Cracks at shell/rib

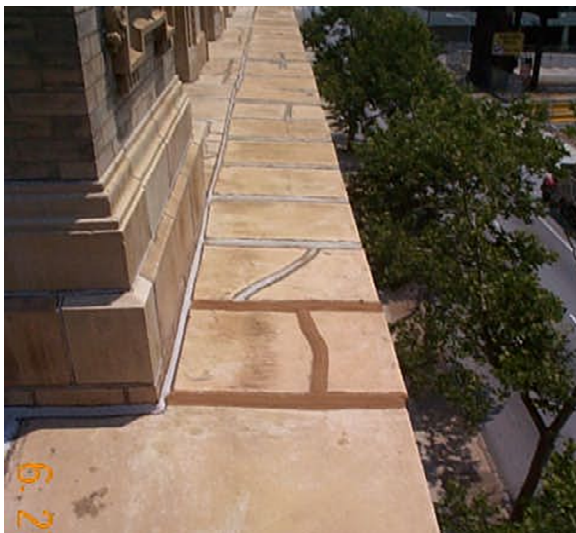
Figure 4. Previous sealant application at cornice cracks

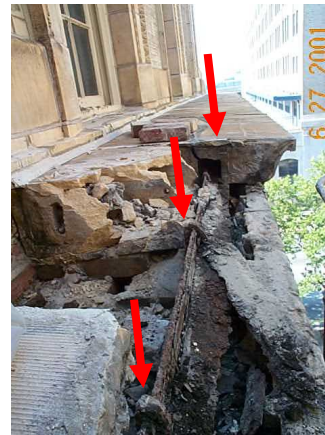
5
6 The cornice on Randell Hall was in very poor condition. The probes exposed severely corroded
7 mild steel back-to-back angles (See Figure 5, Figure 6, Figure 7, and Figure 8.) which align with
8 the cracks in the tops of the cornice. The outer edge of these units were not secure and created
9 a potential fall hazard. The angles provide support for the ‘J’-hooks which suspend modillions
10 below the upper cornice units. A few of these modillions were missing and the ‘J’-hooks were
11 corroded. The terra cotta egg and art / dentil course and others below appeared to be in good
12 condition.
13

Figure 6. Severely corroded back-to-back steel angles aligning with cracks in terra cotta cornice. Outer portion of the cornice is a potential fall hazard.

Since the support steel frame was severely deteriorated and the terra cotta courses that were surrounding and supported by the steel framing were damaged, the project team agreed that the upper 3 courses of terra cotta cornices and supporting framework on Randell Hall needed to be replaced. The lower courses are corbelled out from the brick wall, were substantially back-filled with brick and in good condition. No work was needed there.

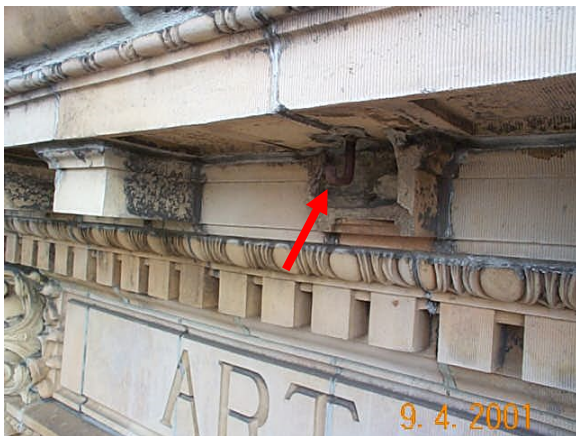
Figure 7. Missing modillion with corroded ‘J’-hook hanger rod on the right. The left modillion is severely deteriorated.

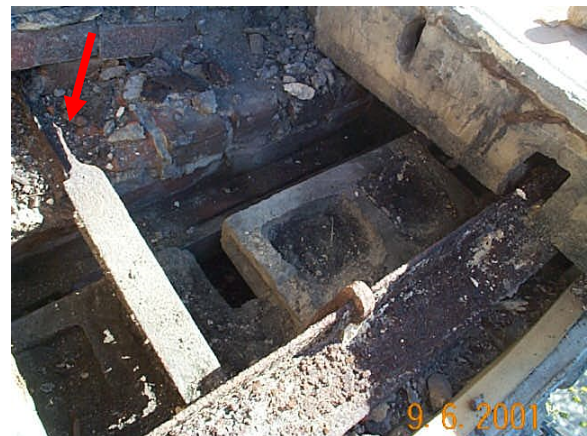
Figure 8. Severely corroded outrigger beam. Top flange is gone.

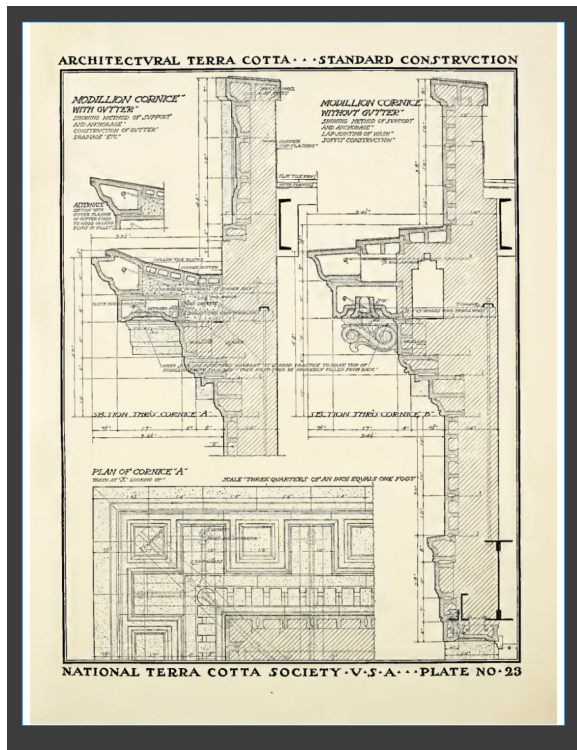
15 The general construction of these cornices was similar to typical details illustrated in Architectural
16 Terra Cotta Standard Construction, National Terra Cotta Society, originally published 1914. (See
17 Figure 9.)
18

Figure 9. Curtis Hall cornice is similar to the detail on the left. Randell Hall is similar to the detail on the right.

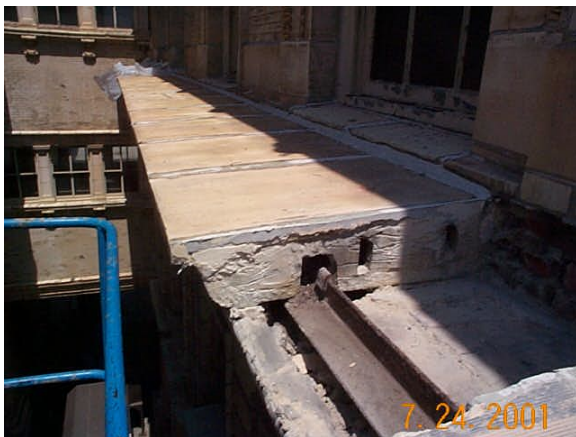
Figure 10. Some locations the steel had not corroded severely and the terra cotta was in good condition. These were used for models

Then samples of each different piece were removed from the building. Color matching and mold fabrication undertaken. Color samples were delivered to the site for project team review, comment and approval. (See Figure 10 and Figure 11.) Rubber molds were taken directly from the terra cotta. (See Figure 12 and Figure 13). Initial samples prepared for size and finish. (See Figure 14.)

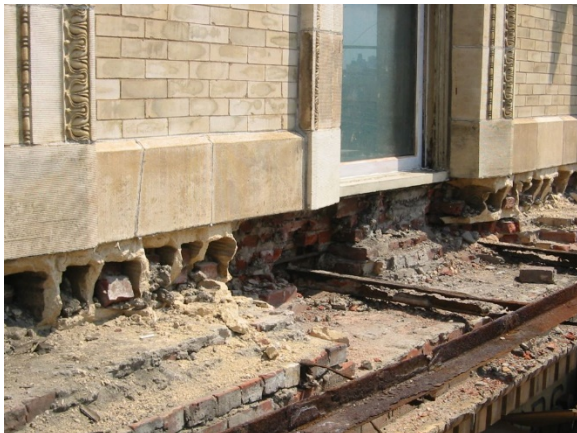
During the GFRP shop fabrication, selective removals and wall preparation was underway. As can be seen in Figure 25, Figure 26, Figure 27 and Figure 28, the steel frame was in worse condition than initially thought. As removals began, many structural steel units failed under their own weight.

Figure 25. Severe corrosion of cornice support steel. Also note back up masonry included terra cotta in compression.

As soon as the old deteriorated terra cotta and steel were removed, the new structural steel framing was installed, this included opening holes into the back up for cantilever beam supports and repairs to deteriorated masonry, setting base plates, etc. This work also had to be coordinated with installing the lower courses of GFRC below the primary support frame. (See Figure 29 and Figure 30.)

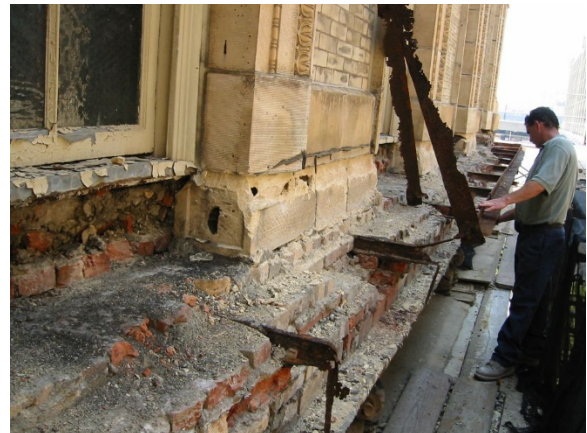
Figure 26. Failed outrigger beams and terra cotta units at base of pier in compression.

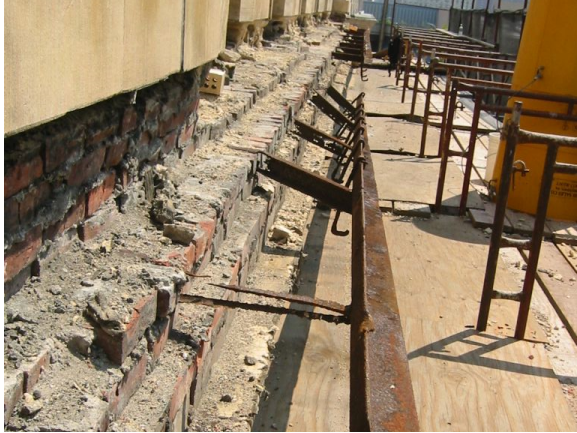
Figure 27. Outriggers failed under their own weight.

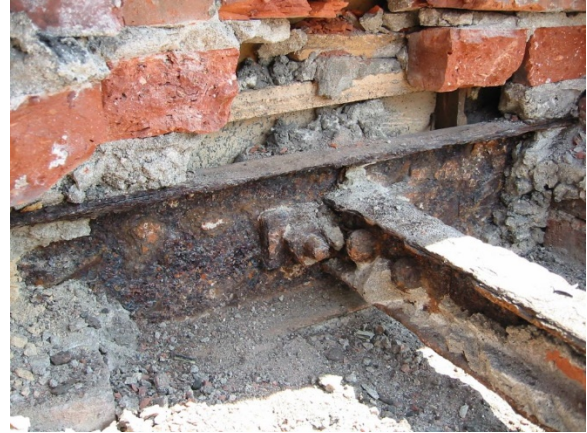
Figure 28. Severe corrosion at joint with embedded façade beam and outrigger

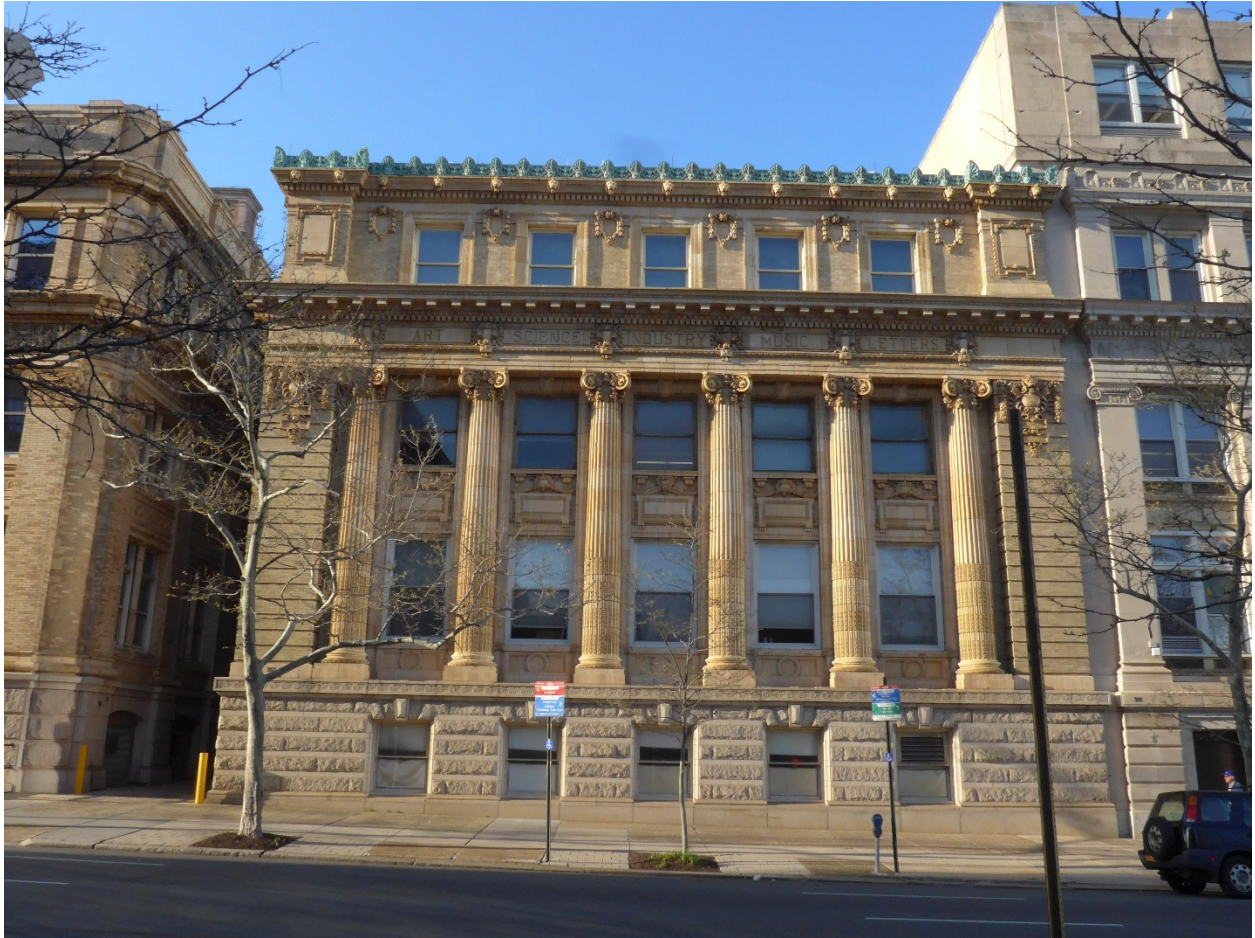
It should be noted that the University value engineered the project and eliminated lead coated copper cap flashing that the engineers had intended to include. In lieu of the sheet metal flashing, urethane sealant and backer rod were installed in the skyward facing joints and mortar provided everywhere else. The rest of the skyward faces of the cornice are exposed to the weather. Upon binocular inspection, it was observed that several of these joints had washed out. However, it should be noted that after 11 years, no discernable deterioration or damage was observed, and the GFRC retains the original colors and clean crisp lines of the original units. (See Figure 41, Figure 42, Figure 43, Figure 44, Figure 45, Figure 46, Figure 47 and Figure 48.)

Figure 41. Randell Building south facade in 2016, 11 years after completion

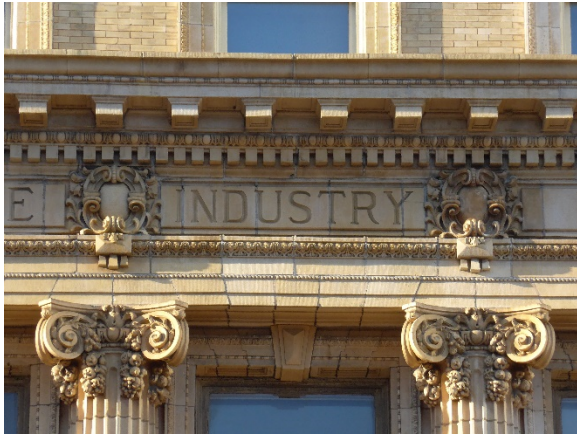
Figure 44. 11-year old GFRC cornice and modillions integrated into historic terra cotta.

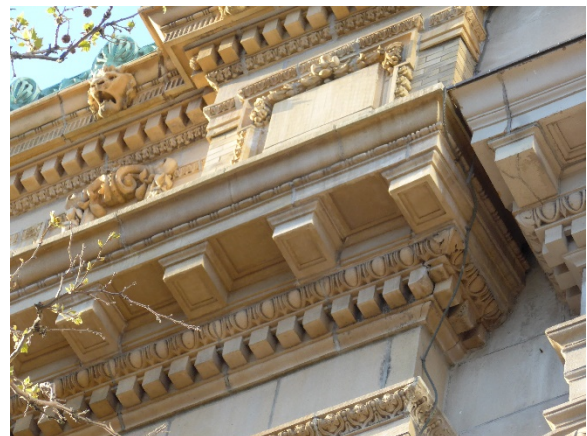
Figure 48. Close up. Note, modillion course and cornice above is 16-year old GFRC, all other masonry is historic terra cotta.
